Technical Service Bulletin

SUBJECT: WATER LEAK AT WINDSHIELD HEADER		No: TSB-11-42A-005	
		DATE: June, 2011	
		MODEL: 2007-12 Eclipse Spyder	
CIRCULATE TO:	<input type="checkbox"/> GENERAL MANAGER	<input checked="" type="checkbox"/> PARTS MANAGER	<input checked="" type="checkbox"/> TECHNICIAN
<input checked="" type="checkbox"/> SERVICE ADVISOR	<input checked="" type="checkbox"/> SERVICE MANAGER	<input checked="" type="checkbox"/> WARRANTY PROCESSOR	<input type="checkbox"/> SALES MANAGER

Some affected vehicles may experience a water leak at the top corners of the windshield header. This TSB provides procedures to improve the sealing performance at the header seal and header garnish to correct this condition.

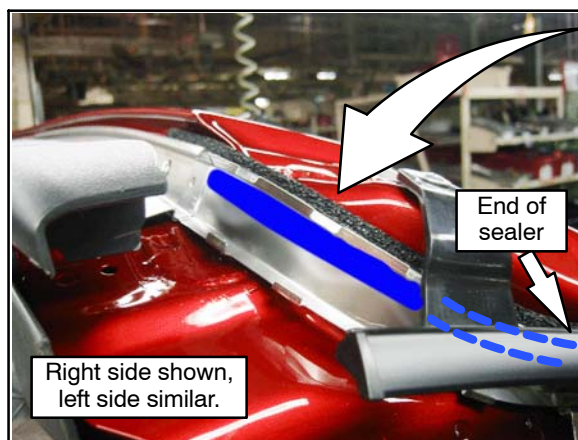
NOTE: Sealer colored blue for photographic visibility.

- c. Apply clear seam sealer to the length of the curved section of the weatherstrip retainer and reinstall the weatherstrip.
